ROLL-ON/ROLL-OFF (RO/RO) DISCHARGE FACILITY TESTS
WITH MV CYGNUS AND SS ATLANTIC BEAR

(COTS CNO PROJECT 299, DT-IIF-1)

SYSTEMS DEVELOPMENT DEPARTMENT
RESEARCH AND DEVELOPMENT REPORT

NOVEMBER 1983

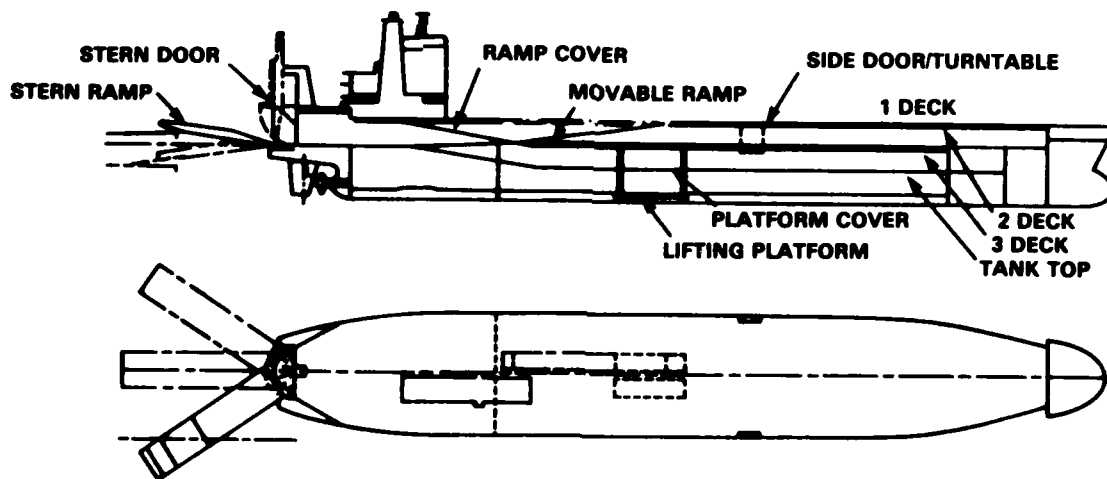
Figure 2 - MV CYGNUS Inboard Profile and Plan Views

The MV CYGNUS represented an ideal self-sustaining RO/RO for testing since its offloading ramp is almost identical to other stern slewing and stern quarter ramps on other self-sustaining RO/ROs. The SS ATLANTIC BEAR represented the ideal nonself-sustaining ship for testing as it is a GREAT LAND Class vessel and is fitted with offloading ports along both the starboard side and transom. PONCE/LURLINE ships do not have transom offloading ports. Other characteristics of the MV CYGNUS and SS ATLANTIC BEAR are noted in the Inboard Profile and Plan Views, Figures 2 and 3, and the RO/RO Ship Characteristic Chart, Table 2.

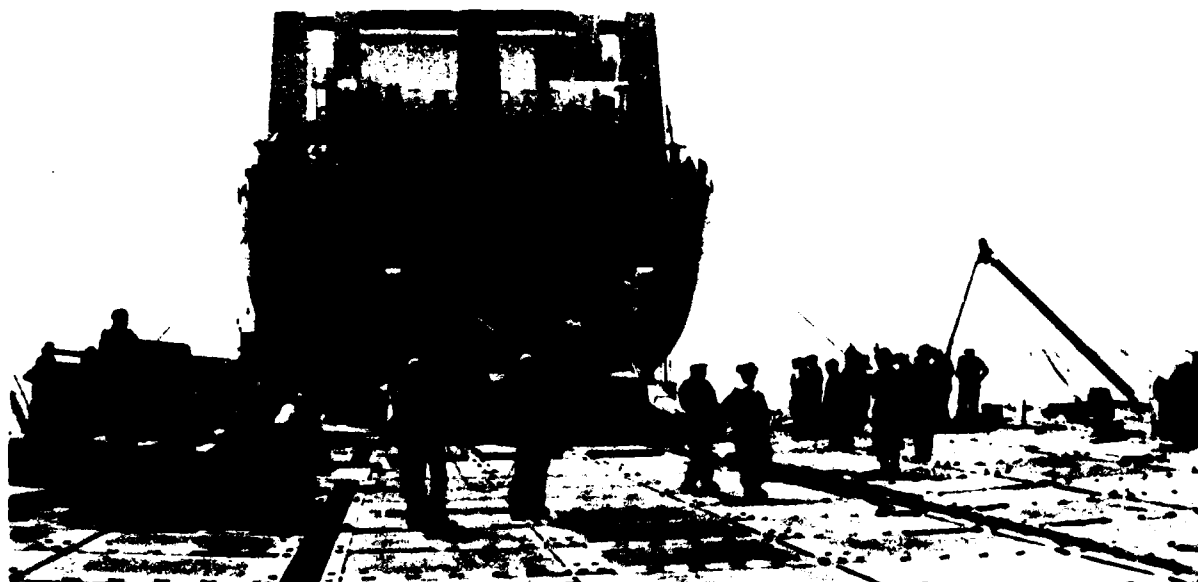
Figure 4 - Causeway Platform Facility (CPF) at the MV CYGNUS

The causeway platform facility is comprised of six standard causeway sections joined together by flexor connectors to form a platform 65 ft wide and 180 ft long. Figure 4 shows the CPF at the MV CYGNUS. With the exception of several pieces of ancillary equipment for the CPF, all of the equipment used in the MV CYGNUS test had been previously tested and evaluated⁴.

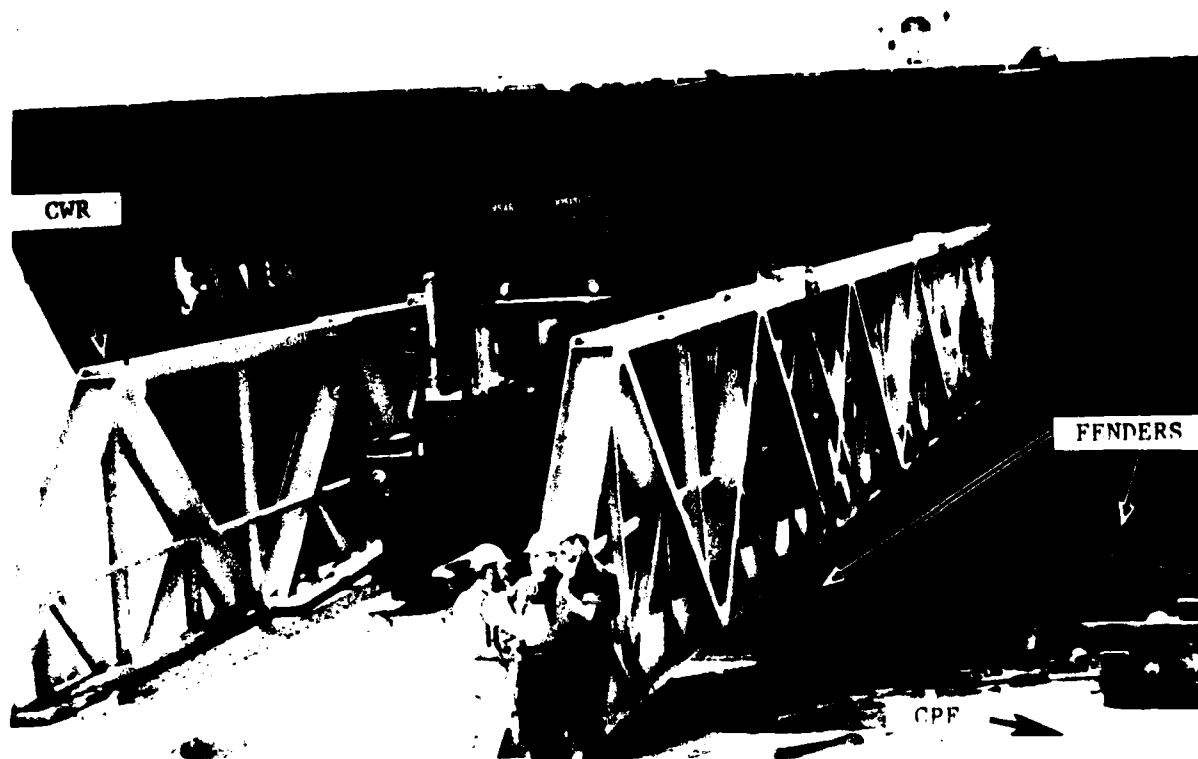
Figure 5 - CPF with CWR and Fenders at the SS ATLANTIC BEAR

In addition to the standard CPF equipment for a self-sustaining vessel, the CPF requires CPF-to-ship fenders and the CWR for operations with a nonself-sustaining vessel. Figure 5 shows this arrangement at the SS ATLANTIC BEAR.

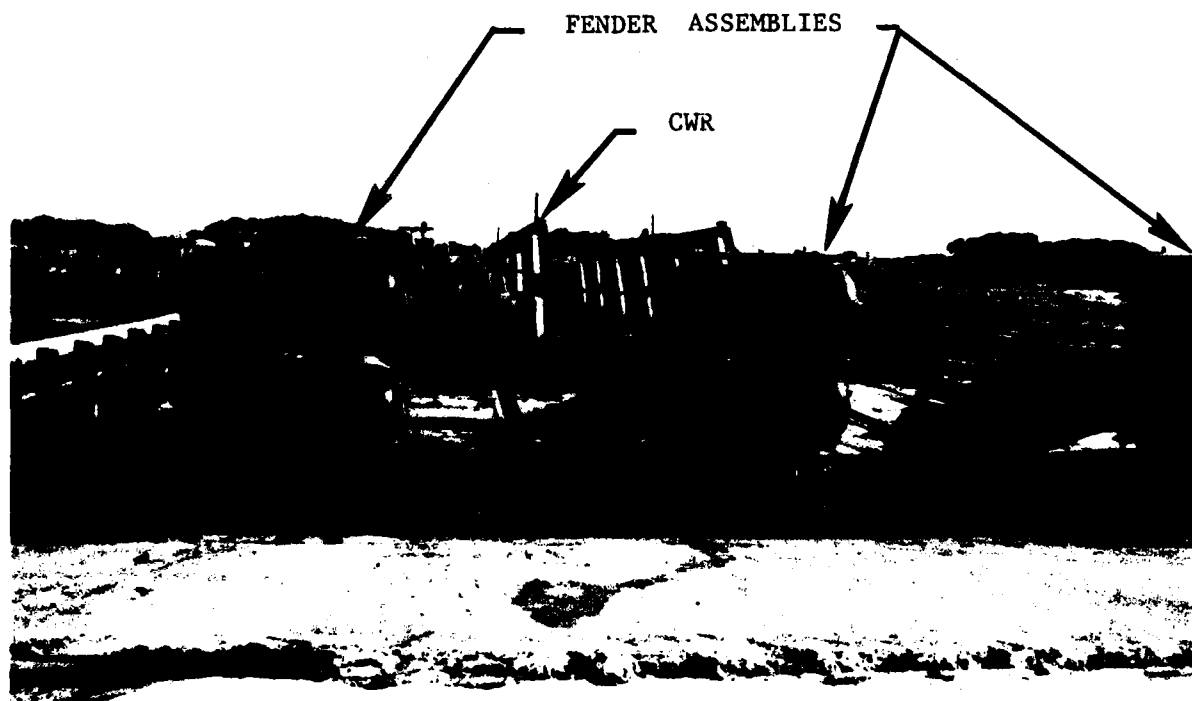
Figure 6 - CPF Fender Assemblies

Three fender assemblies, Figure 6, are required to fend off the CPF from the ship's side or transom. These fender assemblies were previously tested in a simulated side port mooring during tests with the SS AMERICAN TROJAN⁵.

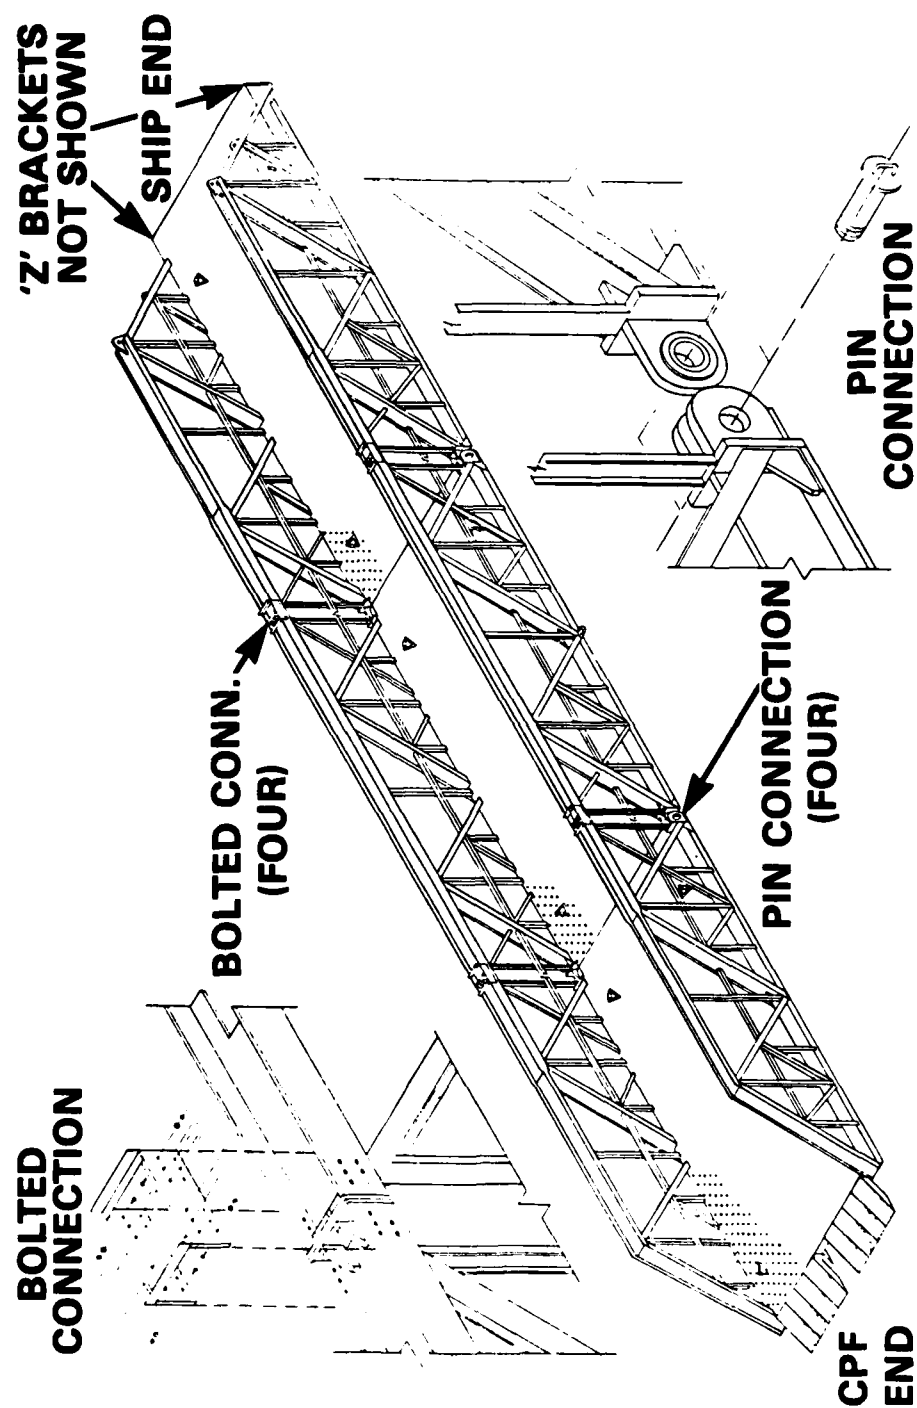
Figure 7 - Calm Water Ramp (CWR)

The CWR, Figure 7, is required to hook up to the ship's offloading port so that the vehicular cargo may drive off. It is the facility's equivalent of the shore-based ramp that would normally be used for loading/offloading at a pier. It is 120 ft long with a clear roadway width of 14 ft. It is pulled into position using the ship's four winch system and held there by two large Z-brackets and support pendants, Figure 8. The total weight of the ramp and brackets is 152,000 lb. Developmental tests of the CWR were conducted during the summer of 1982^{3,5}.

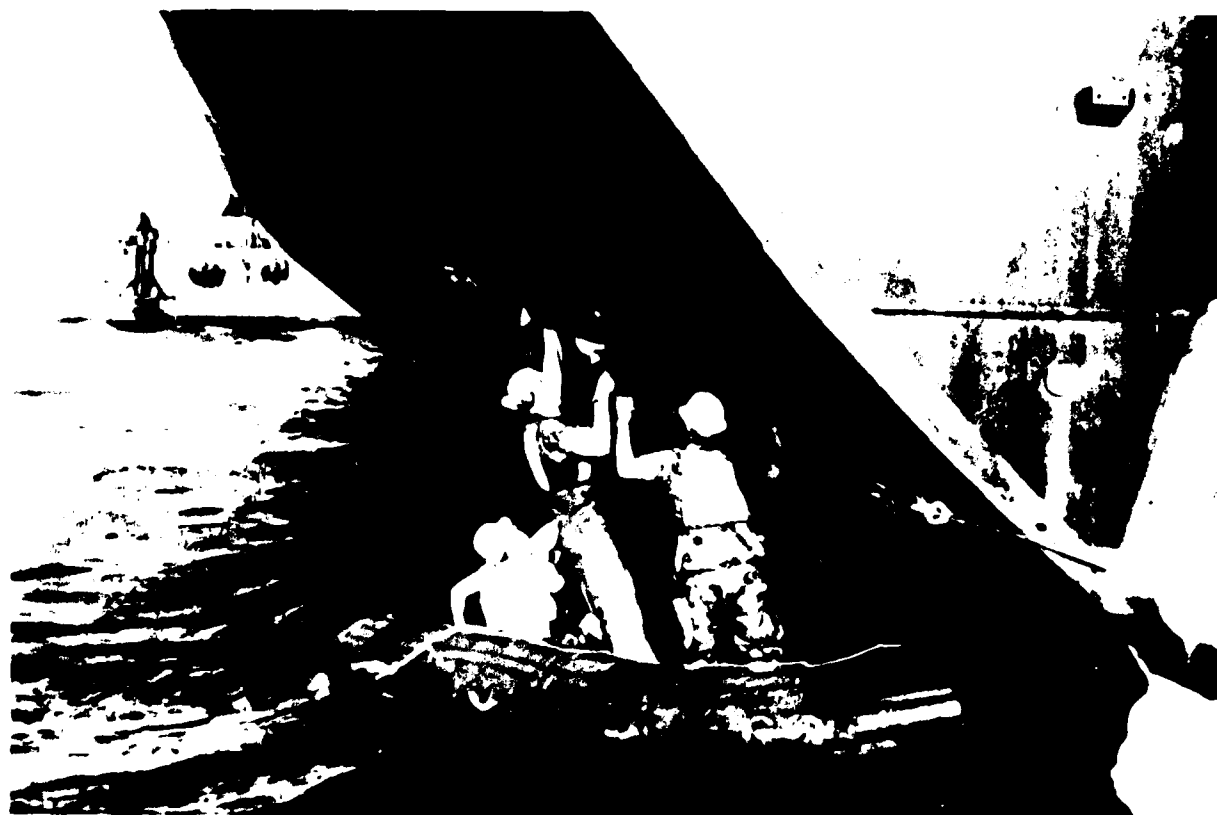
Figure 12 - Installation of Mooring Pendants

In order to facilitate the attachment of the CPF mooring lines to the external padeyes located near the waterline at the stern of the MV CYGNUS four wire rope mooring pendants were installed on the padeyes (see

Figure 12). This permitted a simple shackle connection to the loop in the five in. double braded nylon line which in turn aided in engaging and disengaging the mooring lines to the ship. The wire rope thimbles at the ship's padeyes failed to remain perpendicular to the padeyes which resulted in partial damage of the thimble (see Figures 13 and 14) which caused the thimbles to become wedged on the padeye. This was not a problem until the pendants were removed at which time a boat hook was needed to free them.

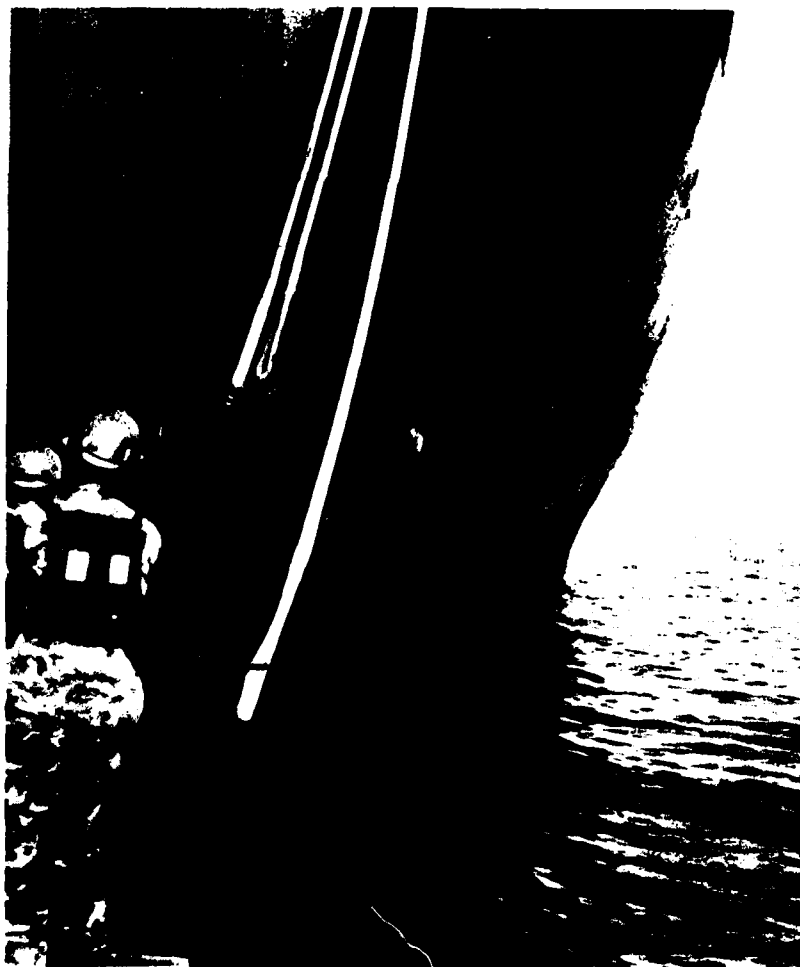
Figure 15 - Passing of CPF Mooring Lines

At the conclusion of the first day of tests, the CPF mooring lines were left attached to the external padeyes and the free ends were passed to the ship where the lines were staged for the next day's operations. This simplified the mooring operations during the remaining days of operation, which necessitated only the passing down of the lines from the ship (see Figure 15).

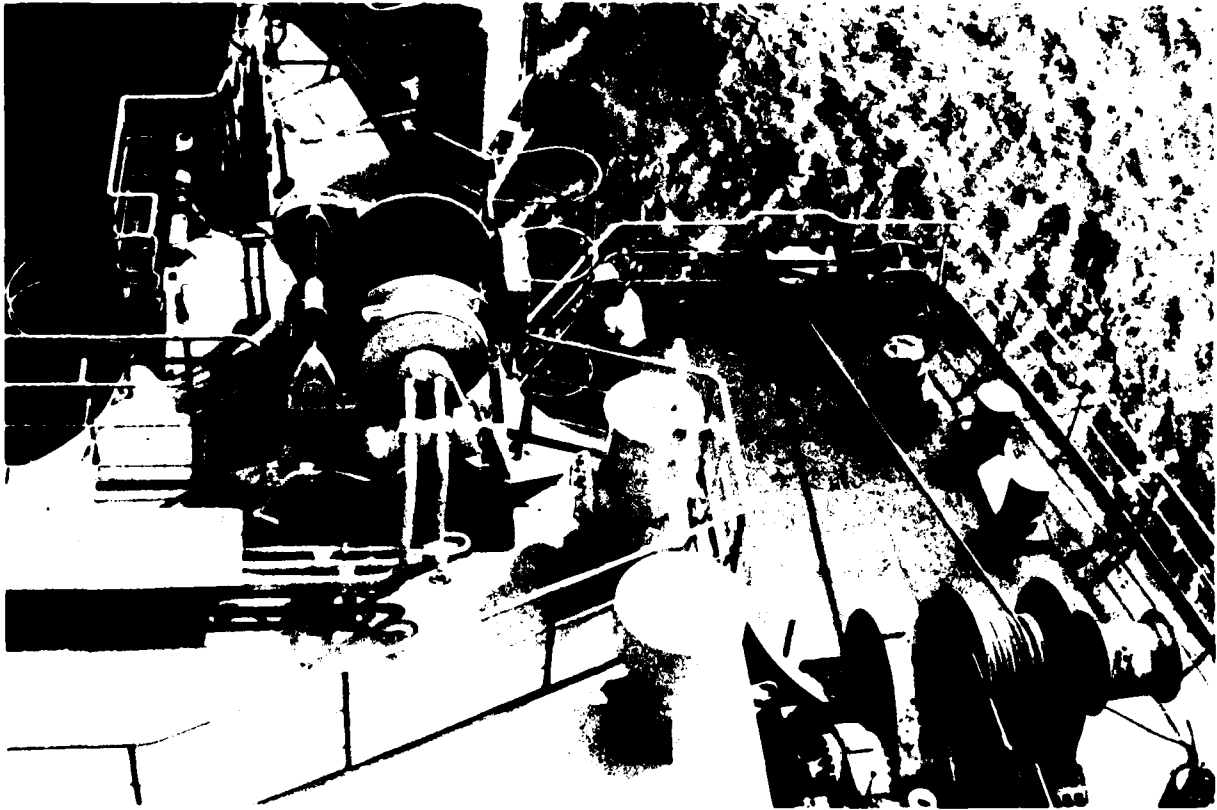
Figure 16 - MV CYGNUS's Aft Mooring Line and Winch

In addition to the mooring lines provided by the CPF, two of the ship's aft mooring lines and winches were used to secure the platform. These were shown in Figures 10 and 16.

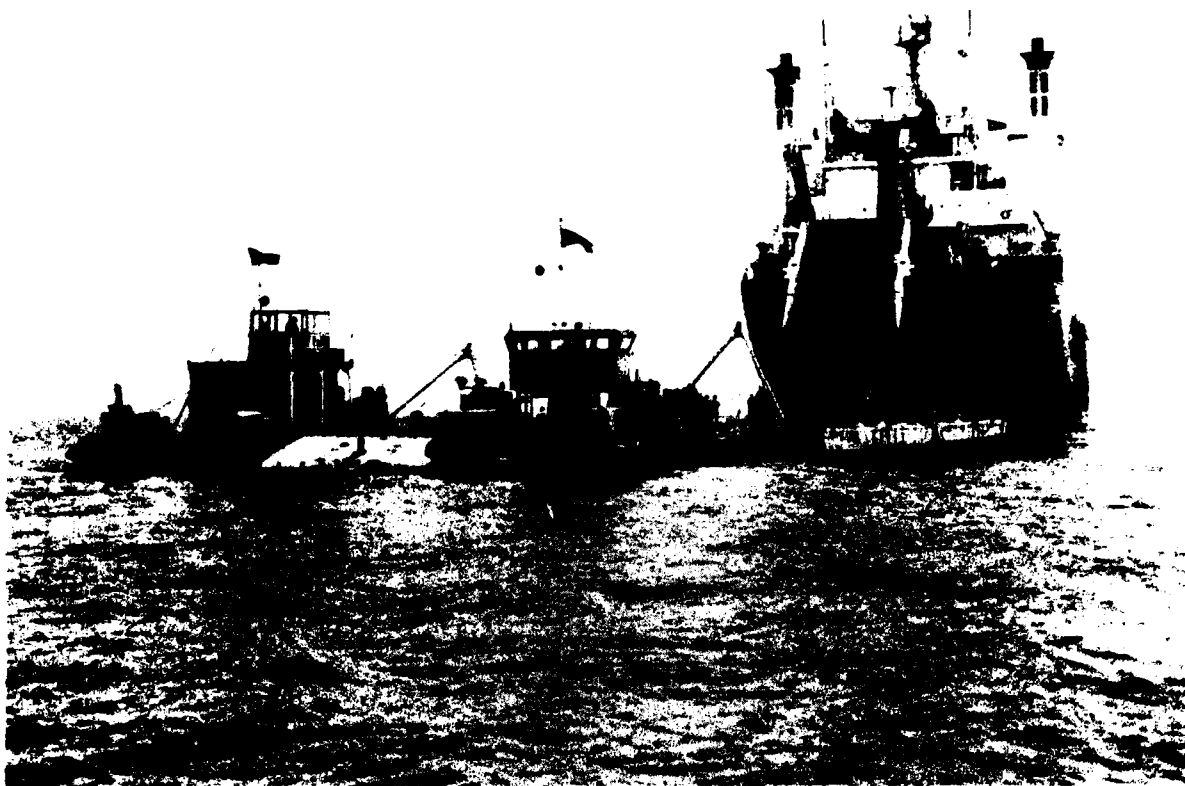
Figure 17 - Positioning of CPF with Two Warping Tugs

Test Results. Two warping tugs were utilized successfully to assemble, transport, and initially position the CPF astern of the ship prior to the lowering of the ramp. During all five days of the exercise, environmental conditions (Sea State 0-1) were such that no additional craft were required (see Figure 17).

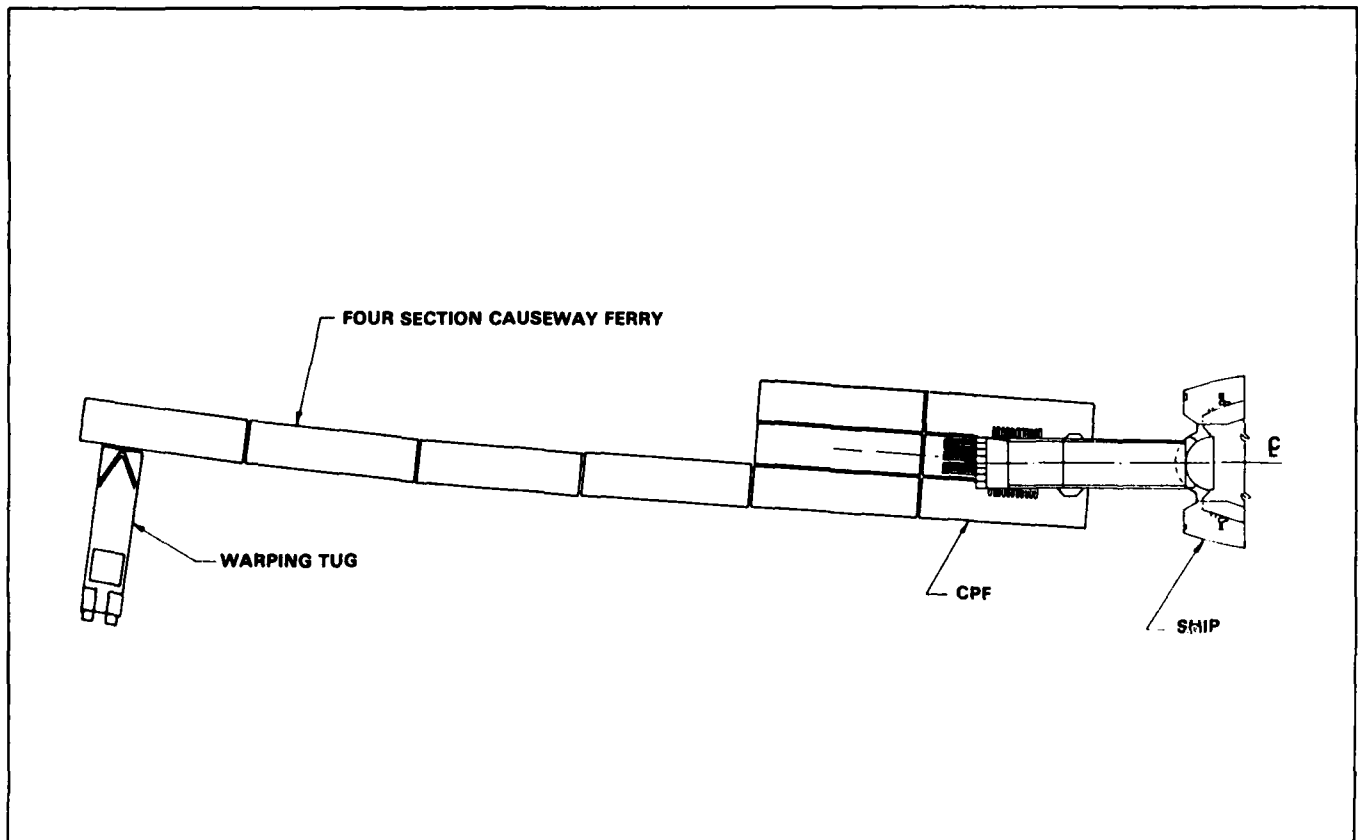
Figure 18 - Rotation of CPF caused by Warring Tug

The use of a warping tug to provide lateral alignment of a Causeway Ferry during the marriage to the CPF resulted in some rotation of the CPF about the ship's ramp (see Figure 18). After the marriage was completed the same warping tug was used to straighten the CPF by pushing in the opposite direction.

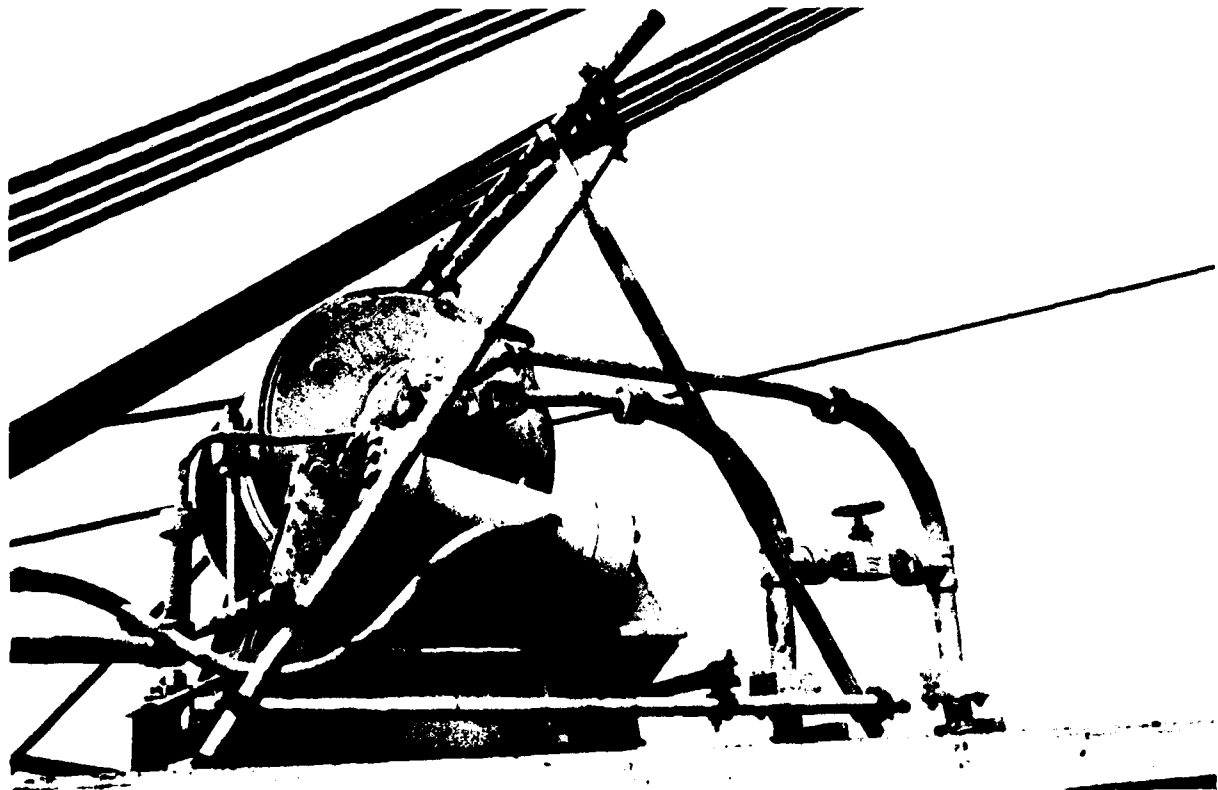
Figure 20 - Hydraulic Station Protection Gear

Once properly installed, however, the cradles adequately protected the hydraulic piping from coming in contact with the ramp's lifting cables (see Figure 20).

1. The hydraulic station protection gear will satisfactorily keep the ramp's lifting cables from coming in contact with the hydraulic piping.

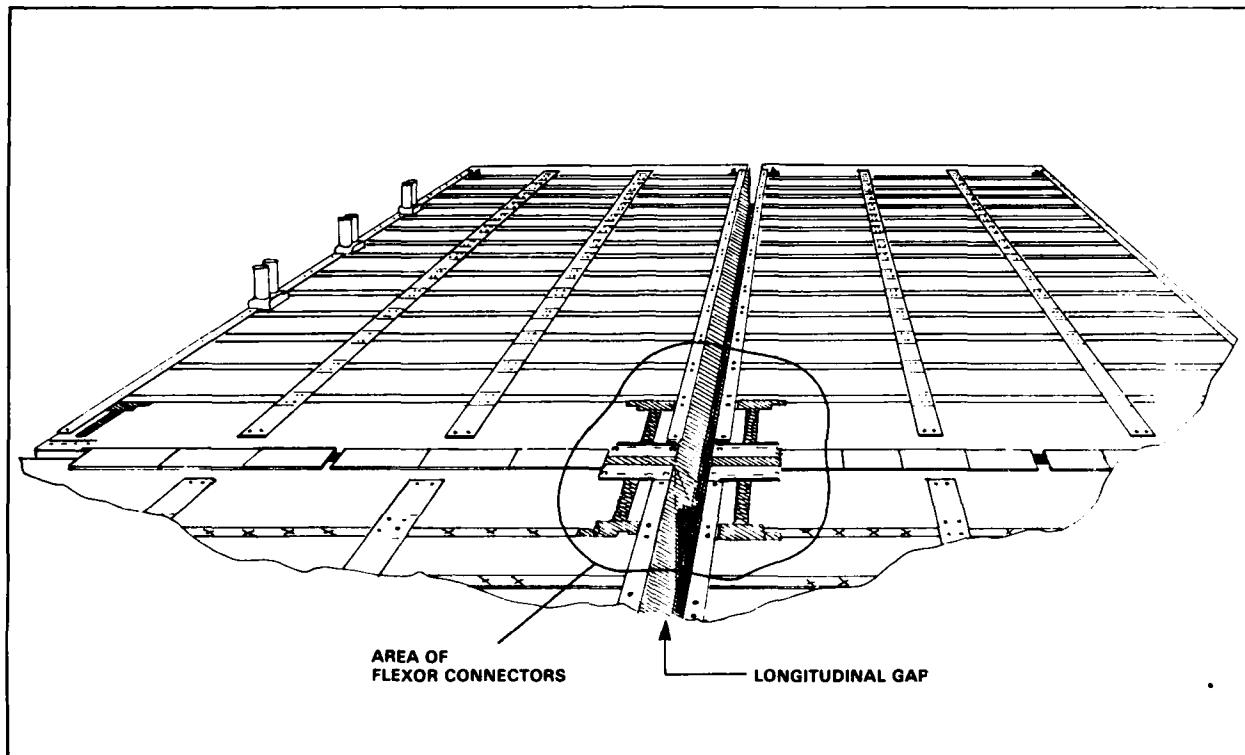
Figure 21 - Longitudinal Gaps in CPF

Test Results. Both configurations of closure plates were easily installed over most of the length of the 13-14 in. longitudinal gap between the causeway sections. Neither configuration, however, could be used to bridge the gap in the area of the end flexors in the middle of the CPF (see Figure 21).

a. Two additional plate designs for covering the gap in the area of the end flexor connectors located in the middle of the CPF.

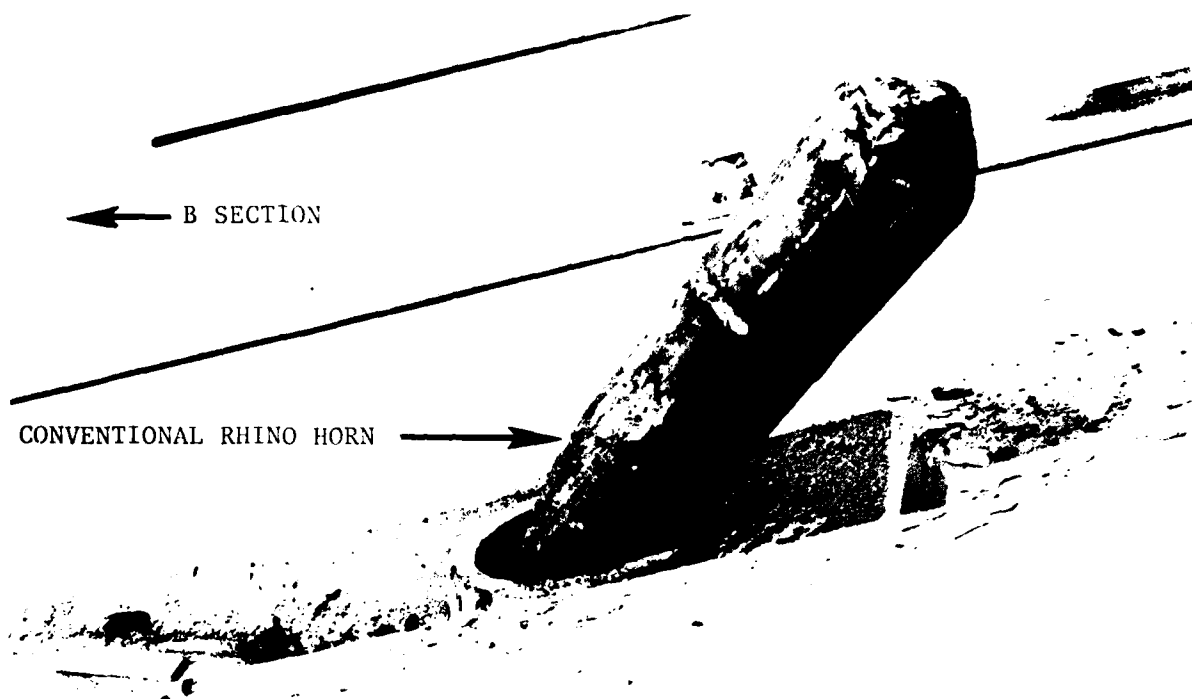
Figure 25 - Conventional Rhino Horn Damaged by LCU Bow Ramp

3. Two portable rhino horns were bent due to misalignment of the LCU bow ramp with the rhino horn during marriage attempts. In both cases the rhino horn was rammed by the LCU ramps that had been lowered too far (see Figures 25 and 26) prior to the LCU being in the correct position for marriage.

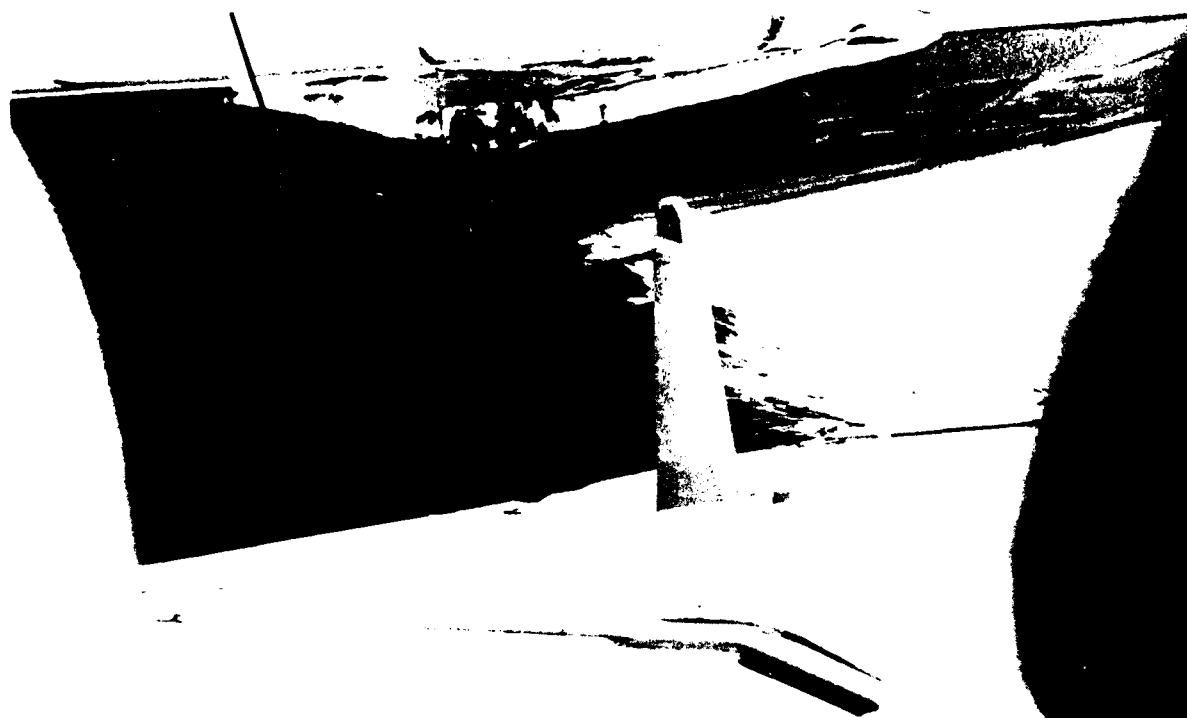
Figure 27 - LCU Bow Marriage with B Section

4. The high strength rhino horn shown in Figure 27 was found to have a tendency to become engaged in the swash holes in the LCU bow ramp during those marriage attempts where the ramp made contact with the rhino horn outside of the "V" notch on the underside of the ramp. This raised concern that damage could be done to the ramp and/or the rhino horn when further alignment was attempted.

LCU BOW RAMP SWASH HOLES

1. The high strength rhino horn has been redesigned following that test with less taper and with a crown on top.

2. After completing the marriage between the bow ramp and rhino horn, the ramp lifting chains must be slacked manually before allowing vehicles to transit the ramp. There must be sufficient slack in the chain so that at least two chain links lay on the LCU's ramp.

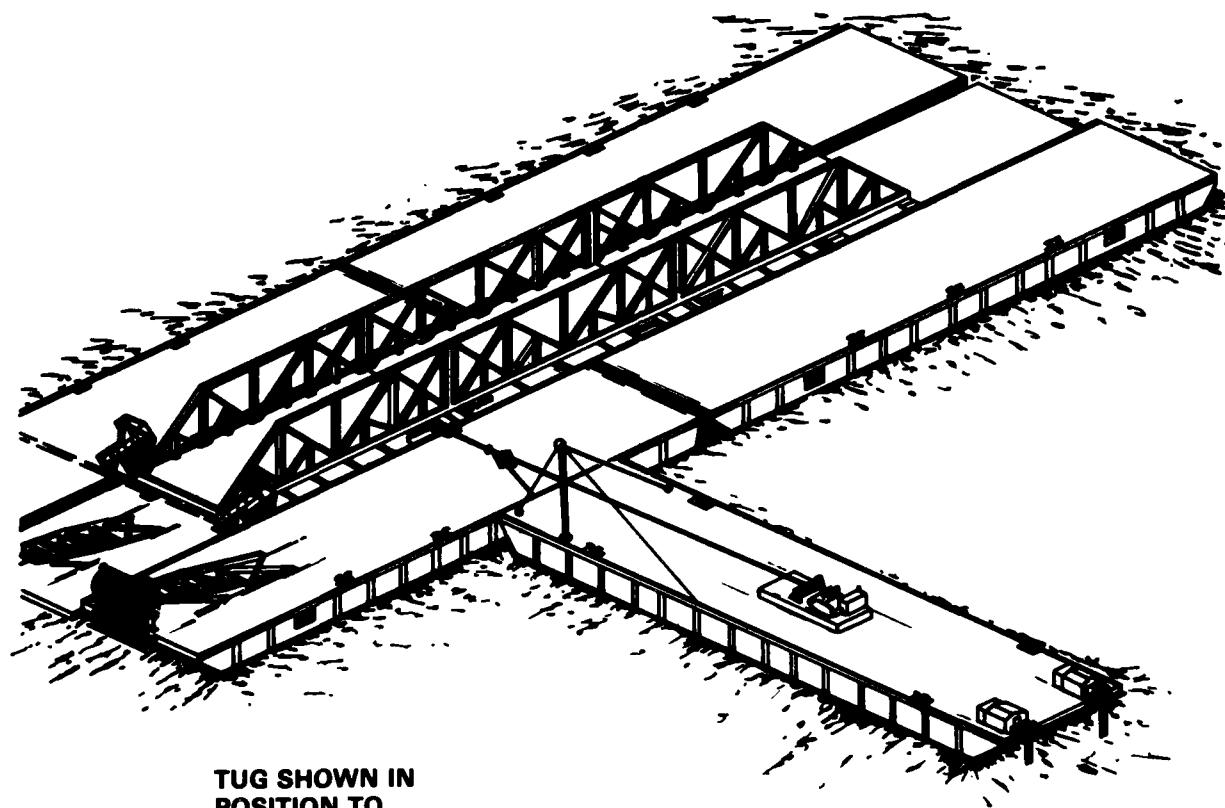
Figure 28 - CPF Assembly

Test Results. The test commenced with the Causeway Platform in two assemblies, a 2 x 2 section plus B section assembly and a 1 x 2 section assembly. The platform assembly was first attempted using methods not discussed in the technical manual. Specifically, a single part purchase vice a two part purchase from the warping tug's winch (see Figure 28) was used to bring the flexors in line vertically during side to side marriage. This resulted in a delay of 35 min. Once the proper methods were used, platform assembly proceeded quickly. Total time elapsed was approximately 1 hr, including the 35 min time delay. The ramp was assembled using methods developed previously and approved in the system technical manual (see Figure 29)^{3,6}. Some difficulty was encountered in

**TUG SHOWN IN
POSITION TO
MAKE SIDE
CONNECTION**

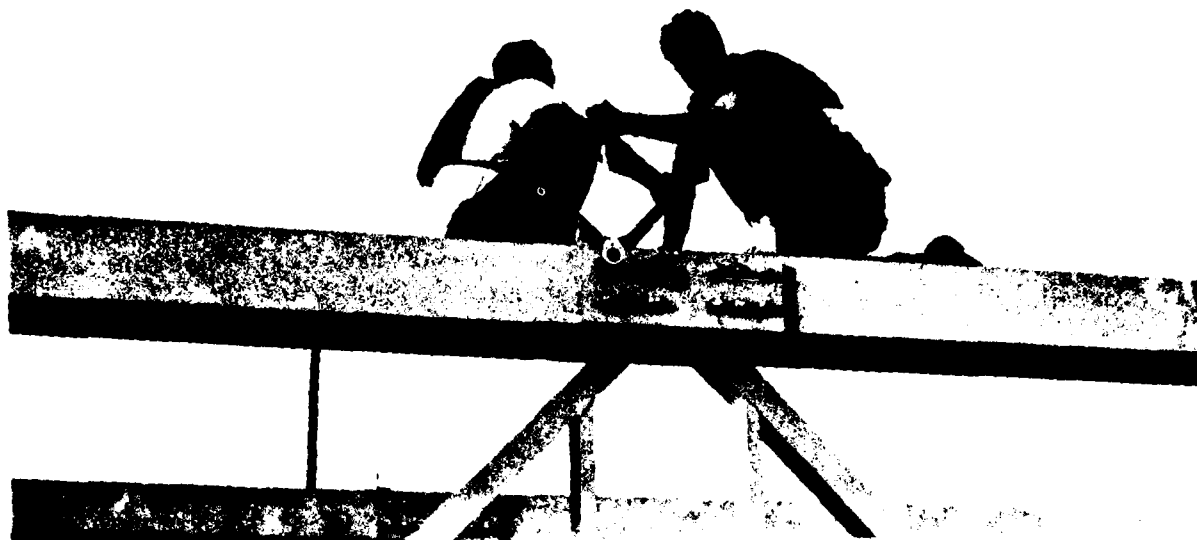
Figure 29 - CWR Assembly

the lowering of the assembled ramp from the blocking onto the ramp pads. The current method of incrementally lowering the ramp to lower blocking with portable hydraulic jacks is slow.

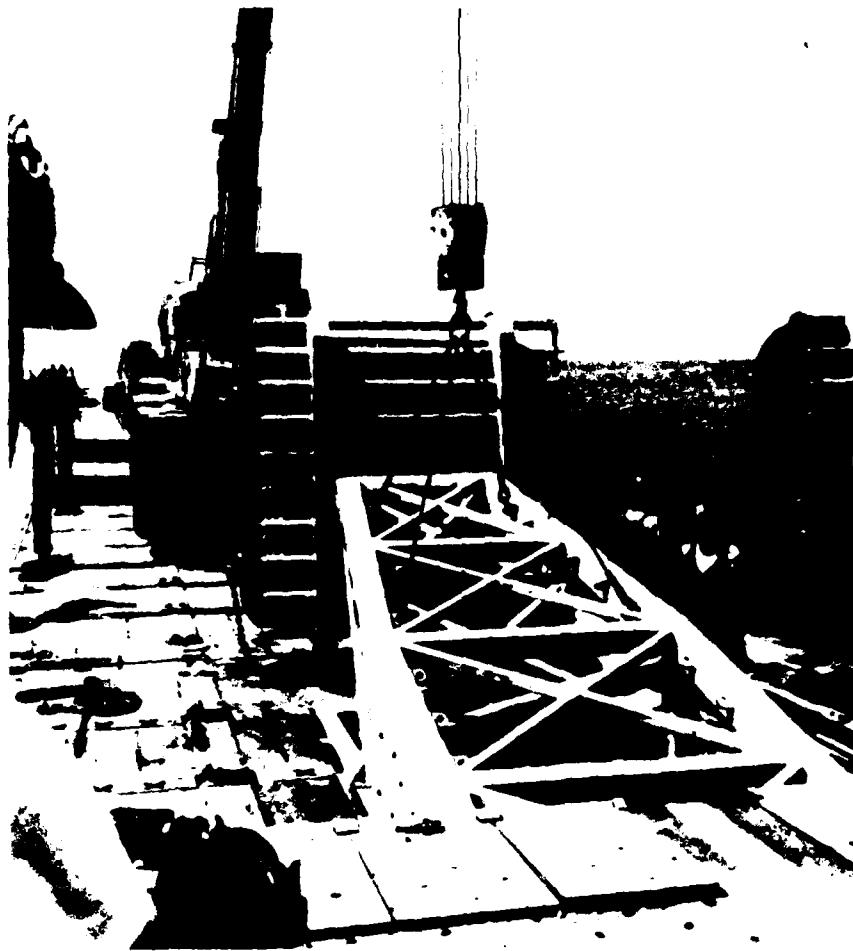
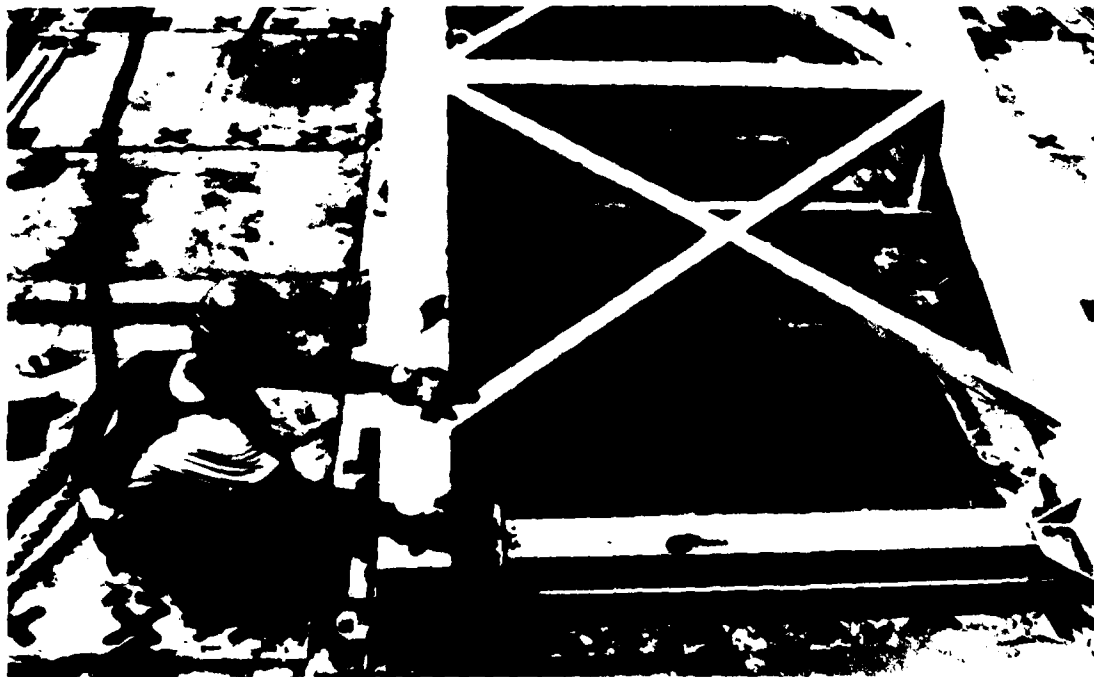
Figure 30 - Fender Assembly Installation

Fender assembly was accomplished using a 30 ton hydraulic crane which was brought to the CPF on a Causeway Ferry. Slight difficulties were encountered in aligning the assemblies with the foundations welded to the causeway platform (see Figure 30).

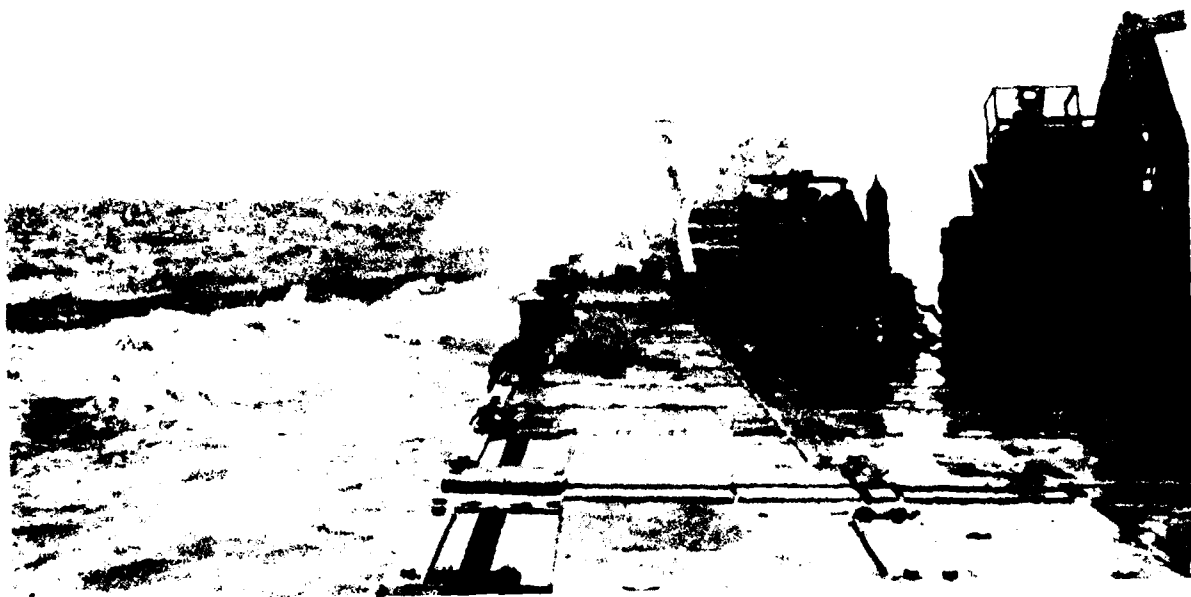
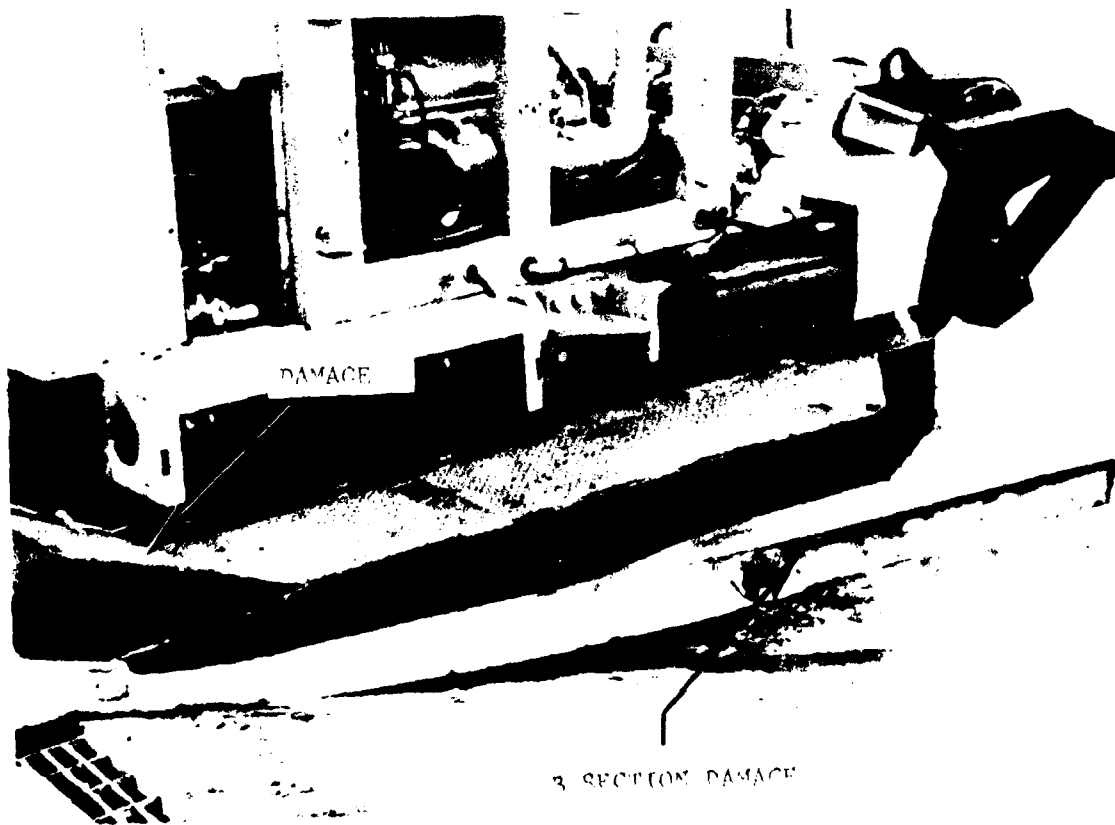
Figure 31 - CPF in Heavy Seas and Resulting Damage

Test Results. Assembly of the platform occurred on 13 September. On 14 September the CPF left Little Creek and encountered heavy seas in the Bay enroute to the SS ATLANTIC BEAR. Several mooring lines between the warping tugs and the CPF parted, warping tug fenders were dislodged, the B section was damaged and one warping tug was damaged. All of the damage resulted from the relative motion between the tugs and the platform. Figure 31 shows the sea conditions and the damaged areas on the B section and the warping tug. It should be noted that both tugs were tied to the B section with only mooring lines. Mooring of the platform to the ship was attempted on 16 September. The platform was maneuvered by two warping tugs connected as shown in Figure 32 in Sea State 2-3 (wave height 2.5-4.0 ft) conditions. One warping tug connected to the CPF with flexors experienced no problems; the other tug tied in conventionally, broke mooring lines repeatedly. Once the CPF was alongside the SS ATLANTIC BEAR, one fender assembly was damaged due to the severe vertical motions (5 to 8 ft) and loads encountered against the ship. The upper fender support pipe contacted the ship's side and after repeated

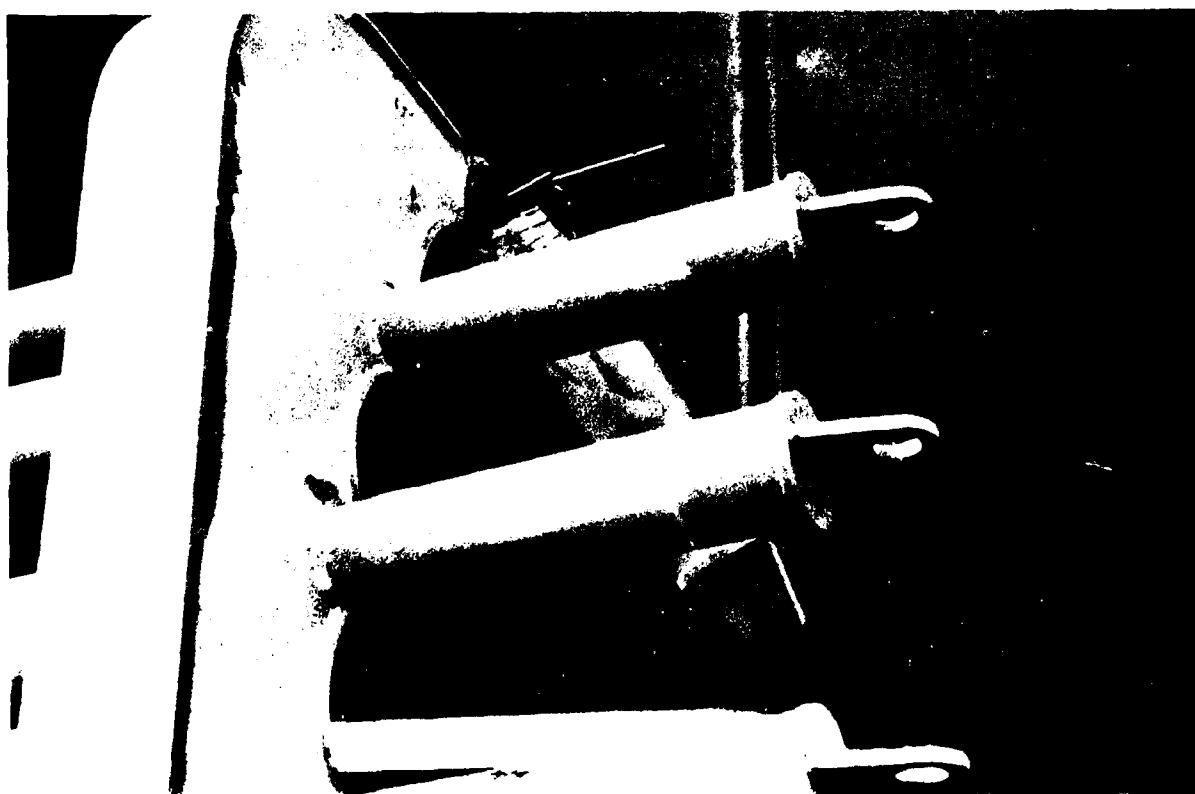
Figure 33 - Fender Damage

contacts it was broken (see Figure 33). In addition it was felt that attaching the mooring lines to the recessed bollards along the ship was too dangerous because of the sea state. The CPF was moving from 5 ft to 8 ft vertically with respect to the side of the ship. Before the CPF was returned to Little Creek for fender repairs the CPF was positioned directly astern of the SS ATLANTIC BEAR at the transom ports. This was done in order to determine the sheltering effect the ship had on reducing the vertical motions of the CPF. The relative motion was much less at the transom location. The CPF vertical motion

b. Using the fender assemblies which have been redesigned to eliminate the problems encountered.
